**Flood Control Project Maintenance
Levee Inspections**

Fall 2018 Levee Maintenance Deficiency Summary Report

San Joaquin River Basin

**Flood Control Project Maintenance
Levee Inspections****LMA District Cover Sheet****Fall 2018 Levee Inspection Results****Reclamation District No. 0404 Boggs**

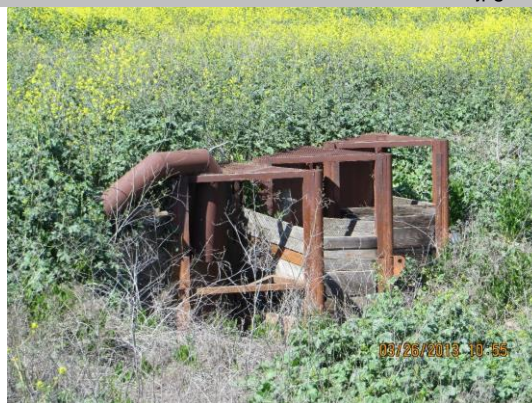
Photo 1 of 3 : UCIP_FA_2018_51168_20041.jpg

LM Start	0.65	Rating **	M	Issue No.	104
LM End	0.65	Issue Type +	En	Location *	
Category	Supplemental			GPS Latitude/Longitude	
				Start	End
Item	DWR UCIP Field Study			37.938670 °	37.938670 °
				-121.335397 °	-121.335397 °
DWR ID	17952				
Comment Code					
Inspector Comment					
FS_ID:51168 DS_ID:17952 EP_NO: N/A Repair Type: Non-Urgent Crossing Status: Found UCIP Comments: Steel intake structure on landside of the levee. FIELD_STRUCT_DESC: 1 of 3: 30-inch corrugated metal gravity drainage pipe through the levee, 22 feet below the crown. Flap gate on the waterside (WS) end. Steel intake structure on the landside (LS). [Additional Reference(s): DWR Levee Log, 2006]. FS Date: 3/26/2013

LS- intake structure

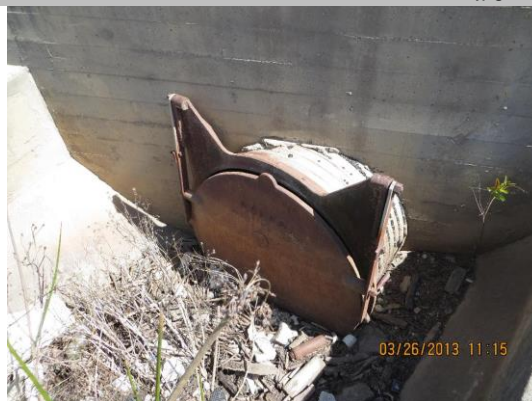
Photo 2 of 3 : UCIP_FA_2018_52607_19962.jpg

Comment Code					
Inspector Comment					
FS_ID:52607 DS_ID:17945 EP_NO: N/A Repair Type: No Action Needed Crossing Status: Found UCIP Comments: 11/22/2017 Received updated photo from DWR levee inspector D. Torres showing gate has been cleared of sediment to allow operation of the gate on the WS. Crossing has been downgraded from Urgent to No Action Needed based on the 2016 photos and the most current photo. Recommend coordinating with City of Stockton to determine as-builts, CVFPB permit, and date of last internal integrity inspection completed for this crossing. (DWR UCIP - O. Magana) 11/29/2016 Flap gate still buried with sediment on WS. Requires clearing. (K. Fazel - UCIP)03/26/2013 Partially buried flap gate (P. Amatya - DWR) FIELD_STRUCT_DESC: 42-inch corrugated metal drainage discharge pipe, 18 feet below the crown. Flap gate, concrete headwall, and spillway on the waterside (WS). Pump house on the landside (LS). Abandoned concrete headwall, power pole, and two wooden piles found on the LS. This drainage pipe likely belongs to the City of Stockton. [Additional Reference(s): DWR Levee Log, 2006. USACE San Joaquin O&M Manual 1, March 1963, (HLM 0.78)]. FS Date: 11/22/2017

WS- drainage outlet structure and CM pipe with flapgate

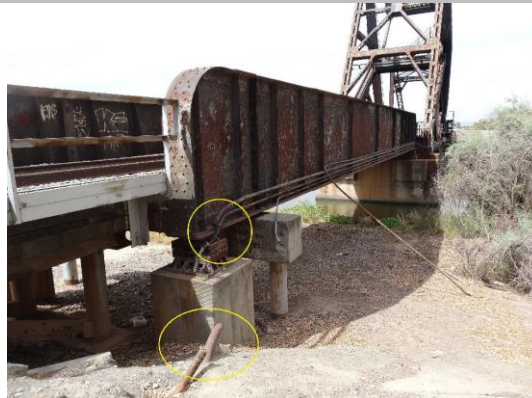
Photo 2 of 3 : UCIP_FA_2018_46810_74754.jpg

LM Start	0.79	Rating **	M	Issue No.	108	
LM End	0.79	Issue Type +	En	Location *		
Category	Supplemental			GPS Latitude/Longitude		
				Start	End	
Item	DWR UCIP Field Study			37.937212°	37.937212°	
				-121.333762°	-121.333762°	
DWR ID	17946					
Comment Code						
Inspector Comment						
FS_ID:46810						
DS_ID:17946						
EP_NO: N/A						
Repair Type: Non-Urgent						
Crossing Status: Found						
UCIP Comments: Appears abandoned; if so should be done so properly.						
FIELD_STRUCT_DESC: Telephone conduit of an unknown size or material through both levees and under the San Joaquin River, at an unknown depth. This buried telephone cable is no longer operational.						
[Additional Reference(s): DWR Levee Log, 2006].						
FS Date: 8/4/2015

WS view looking west: conduits thru levee and attached to bridge

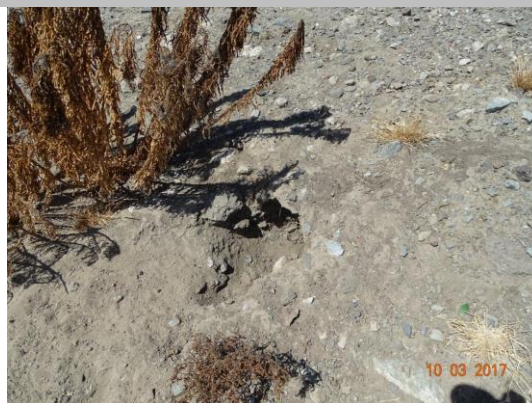
Photo 1 of 2 : FA_2018_RD0404_305_42_20180906_00016.jpg

LM Start	0.98	Rating **	U	Issue No.	42
LM End	0.98	Issue Type +	Ma	Location *	WS
Category	Earthen Levee			GPS Latitude/Longitude	
				Start	End
Item	Animal Control			37.935918 °	37.935918 °
				-121.331032 °	-121.331032 °
DWR ID	DWR_RD0404_01_s_2017_42				
Comment Code					
A3 : No rodents visible, but rodent burrows visible; need to backfill and compact or grout burrows.					
Inspector Comment

View of the waterside slope looking southwest.

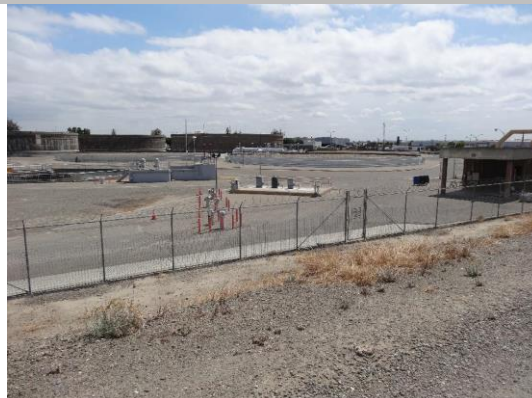
Photo 1 of 3 : UCIP_FA_2018_46801_74745.jpg

Comment Code					
Inspector Comment					
FS_ID:46801 DS_ID:25128 EP_NO: 1164 Repair Type: Non-Urgent Crossing Status: Indicator Found UCIP Comments: Conversation with WWTP engineer Ali Gharegozloo suggested this pipe has been welded shut. If so, mode of abandonment needs verification. FIELD_STRUCT_DESC: 60-inch lock joint reinforced concrete sewage effluent pipe under the levee, 27 feet below the crown. Reinforced concrete apron and cutoff walls. Steel sheet piling apron installed with the pipe on the waterside (WS) slope. Headwall, stairs, and pump with shutoff valve visible on the WS slope. Apparent shutoff valves 30 feet off the landside (LS) toe in alignment with the pipe. (Plans for the construction of a 60-inch lock joint reinforced concrete sewage effluent pipe under the easterly levee of the San Joaquin River authorized under Permit No. 1164, 1947 - City of Stockton). FS Date: 7/9/2015

LS view: apparent shut off valves on WWTP property in alignment with 60-inch pipe.

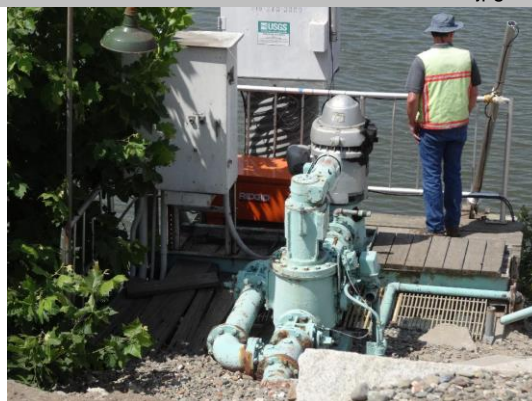
Photo 3 of 3 : UCIP_FA_2018_46801_74748.jpg

Comment Code						
Inspector Comment						
FS_ID:46801 DS_ID:25128 EP_NO: 1164 Repair Type: Non-Urgent Crossing Status: Indicator Found UCIP Comments: Conversation with WWTP engineer Ali Gharegozloo suggested this pipe has been welded shut. If so, mode of abandonment needs verification. FIELD_STRUCT_DESC: 60-inch lock joint reinforced concrete sewage effluent pipe under the levee, 27 feet below the crown. Reinforced concrete apron and cutoff walls. Steel sheet piling apron installed with the pipe on the waterside (WS) slope. Headwall, stairs, and pump with shutoff valve visible on the WS slope. Apparent shutoff valves 30 feet off the landside (LS) toe in alignment with the pipe. (Plans for the construction of a 60-inch lock joint reinforced concrete sewage effluent pipe under the easterly levee of the San Joaquin River authorized under Permit No. 1164, 1947 - City of Stockton). FS Date: 7/9/2015

WS view: closeup of pump. CMP riser for USGS gage behind pump.

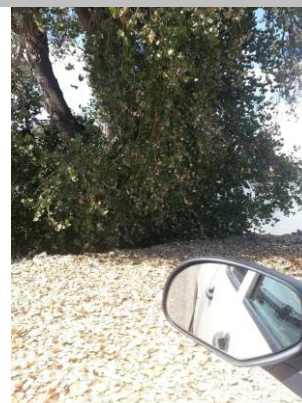
Photo 1 of 1 : FA_2018_RD0404_305_27_20180906_00011.jpg

LM Start	1.50	Rating **	M	Issue No.	27
LM End	1.50	Issue Type +	Ma	Location *	WS
Category	Earthen Levee			GPS Latitude/Longitude	
				Start	End
Item	Trim / Thin Trees			37.896544 °	37.896544 °
				-121.327121 °	-121.327121 °
DWR ID	DWR_RD0404_01_f_2016_27				
Comment Code					
T2 : Thin trees to allow visibility of the ground and room to flood fight.					
Inspector Comment

Looking west at untrimmed trees on waterward slope.

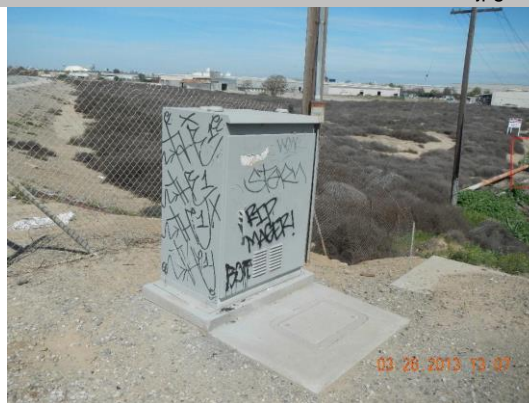
Photo 1 of 3 : UCIP_FA_2018_50763_20104.jpg

Comment Code					
Inspector Comment					
FS_ID:50763 DS_ID:18708 EP_NO: 4175 Repair Type: Non-Urgent Crossing Status: Found UCIP Comments: 11/17/2016 FPIIB Inspector Richard Willoughby noted 3-4 inch depression over pipes on crown, an indication of possible pipe collapse. (K. Fazel - UCIP) FIELD_STRUCT_DESC: 1 of 2: 12-inch steel drainage discharge pipe through the levee, 5 feet below the crown. Siphon breaker on the waterside (WS) shoulder. Power pole, electrical control panel, and pump about 200 feet off the landside (LS) toe. (Plans for installation of a 10-inch, 12-gauge welded steel discharge pipe over the levee authorized under Permit No. 4175, 1963 - City of Stockton). [Additional Reference(s): DWR Levee Log, 2006]. FS Date: 11/17/2016

LS- overview of pipe and pump (far right)

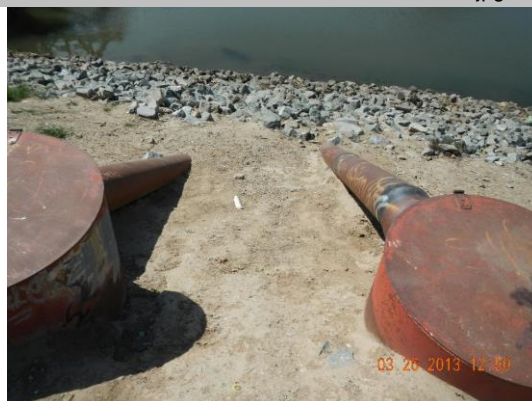
Photo 2 of 3 : UCIP_FA_2018_50763_20103.jpg

Comment Code						
Inspector Comment						
FS_ID:50763 DS_ID:18708 EP_NO: 4175 Repair Type: Non-Urgent Crossing Status: Found UCIP Comments: 11/17/2016 FPIIB Inspector Richard Willoughby noted 3-4 inch depression over pipes on crown, an indication of possible pipe collapse. (K. Fazel - UCIP) FIELD_STRUCT_DESC: 1 of 2: 12-inch steel drainage discharge pipe through the levee, 5 feet below the crown. Siphon breaker on the waterside (WS) shoulder. Power pole, electrical control panel, and pump about 200 feet off the landside (LS) toe. (Plans for installation of a 10-inch, 12-gauge welded steel discharge pipe over the levee authorized under Permit No. 4175, 1963 - City of Stockton). [Additional Reference(s): DWR Levee Log, 2006]. FS Date: 11/17/2016

WS- steel pipes and siphon breakers in steel pipe risers.

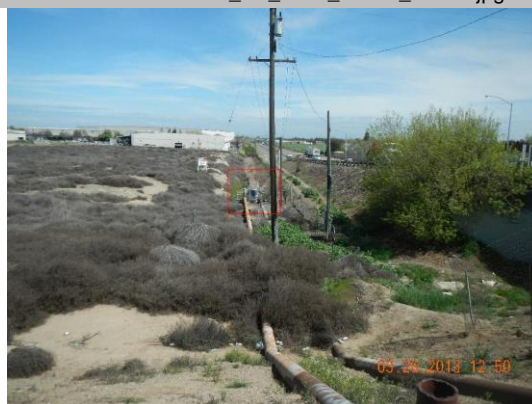
Photo 3 of 3 : UCIP_FA_2018_50763_20102.jpg

LS- pipes and pumps (center)

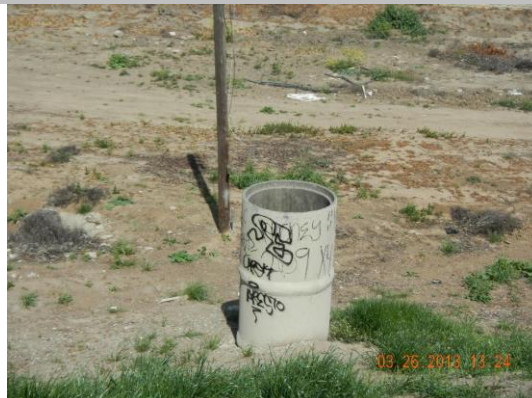
Photo 2 of 3 : UCIP_FA_2018_40487_20063.jpg

Comment Code						
Inspector Comment						
FS_ID:40487						
DS_ID:18812						
EP_NO: 10897						
Repair Type: Non-Urgent						
Crossing Status: Found						
UCIP Comments: Abandoned crossing. WS pipe capped with steel pipe and LS pipe cut.						
FIELD_STRUCT_DESC: *ABANDONED* 14-inch irrigation discharge pipe of an unknown material through the levee, 3 feet below the crown. Siphon breaker on the waterside (WS). (Plans to install a 20-horsepower irrigation pump on an existing structure and a 14-inch discharge pipe through the levee authorized under Permit No. 10897, 1975 - Alfred Volpi. 14-inch pipe replaces existing 12-inch pipe).						
[Additional Reference(s): DWR Levee Log, 2006. USACE San Joaquin O&M Manual 1, March 1963, (HLM 1.63), 12-inch pipe referenced, 5.5 feet below the crown].						
FS Date: 3/26/2013

LS- concrete standpipe on levee slope

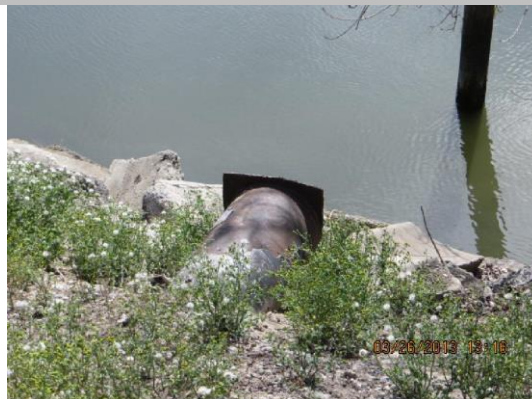
Photo 3 of 3 : UCIP_FA_2018_40487_20065.jpg

WS- abandoned steel pipe capped with steel plate.

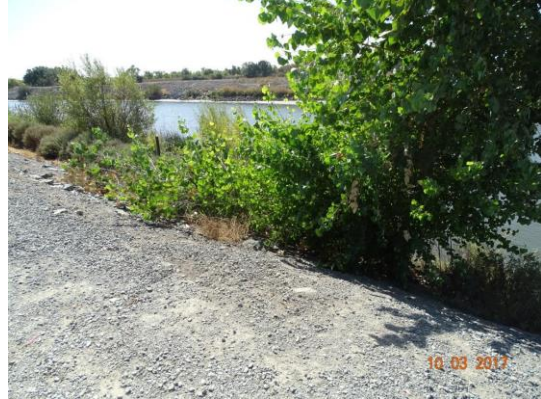
Photo 1 of 1 : FA_2018_RD0404_305_22_20180906_00010.jpg

LM Start	2.14	Rating **	M	Issue No.	22
LM End	2.14	Issue Type +	Ma	Location *	WS
Category	Earthen Levee			GPS Latitude/Longitude	
				Start	End
Item	Trim / Thin Trees			37.922040 °	37.922040 °
				-121.321446 °	-121.321446 °
DWR ID	DWR_RD0404_01_f_2017_22				
Comment Code					
T1 : Trim trees to at least five feet above ground level.					
Inspector Comment

View of the waterside slope looking south.

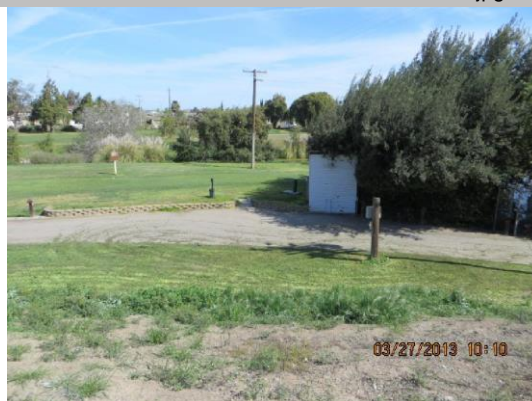
Photo 3 of 3 : UCIP_FA_2018_10908_18180.jpg

Comment Code						
Inspector Comment						
FS_ID:10908 DS_ID:18781 EP_NO: 3340A Repair Type: Non-Urgent Crossing Status: Found UCIP Comments: - Not working for 5 years- Golf club staff- Wooden Walkway; Concrete steps- Damaged siphon breaker FIELD_STRUCT_DESC: 6-inch steel irrigation discharge pipe through the levee, 2 feet below the crown. One corrugated metal cutoff wall. Pump on a pile structure in the stream. Shutoff valve and siphon breaker on the waterside (WS) shoulder. Timber walkway on the WS slope. (Plans for installation of three pumping plants on the north levee of French Camp Slough authorized under Permit No. 3340-A, 1960 - City of Stockton). [Additional Reference(s): DWR Levee Log, 2006]. FS Date: 3/27/2013

LS- overview of LS slope

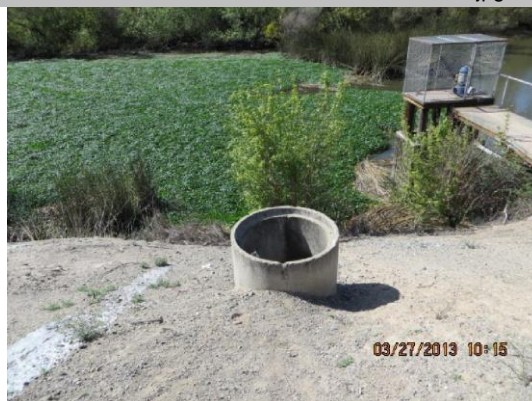
Photo 2 of 3 : UCIP_FA_2018_10945_18247.jpg

WS- concrete riser on steep levee slope

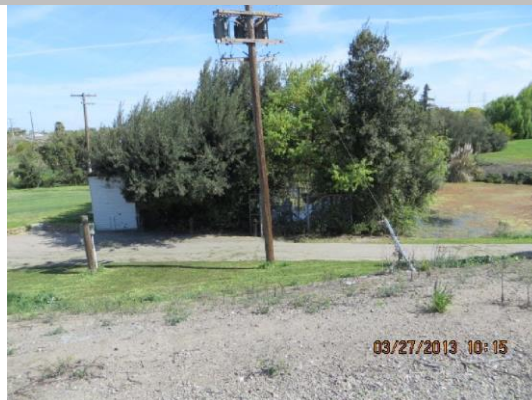
Photo 3 of 3 : UCIP_FA_2018_10945_18250.jpg

Comment Code						
Inspector Comment						
FS_ID:10945						
DS_ID:18782						
EP_NO: 4448						
Repair Type: Non-Urgent						
Crossing Status: Found						
UCIP Comments: Concrete stairway on waterward slope- Not found.						
Pump was working during field survey. Siphon breaker cap missing.						
FIELD_STRUCT_DESC: 18-inch steel drainage discharge pipe through the levee, 9.3 feet below the crown. Pump on the landside (LS). Two corrugated metal cutoff walls. Siphon breaker in a concrete well on the waterside (WS) shoulder. (Plans for installation of a discharge pipe through the levee authorized under Permit No. 4448, 1964 - City of Stockton, Department of Public Works). [Additional Reference(s): DWR Levee Log, 2006].						
FS Date: 3/27/2013

LS- overview of pumping plant and levee slope

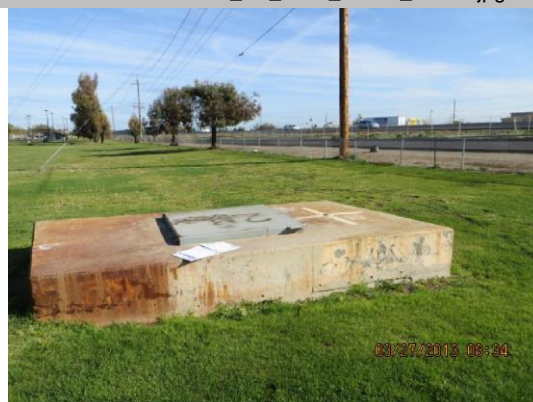
Photo 1 of 3 : UCIP_FA_2018_10846_18127.jpg

LM Start	1.76	Rating **	M	Issue No.	29
LM End	1.76	Issue Type +	En	Location *	
Category	Supplemental			GPS Latitude/Longitude	
				Start	End
Item	DWR UCIP Field Study			37.917284 °	37.917284 °
				-121.291740 °	-121.291740 °
DWR ID	18804				
Comment Code					
Inspector Comment					
FS_ID:10846 DS_ID:18804 EP_NO: N/A Repair Type: Non-Urgent Crossing Status: Indicator Found UCIP Comments: Only a 7 ft x 14 ft concrete vault found on LS.Needs a sign post.Bob Winter from KSN(representative of RD 404) will investigate on this crossing. FIELD_STRUCT_DESC: 1 of 2: 42-inch reinforced concrete sewer line through the levee, 8 feet below the crown. Pipe crosses another 42-inch sewer line under the channel. [Additional Reference(s): DWR Levee Log, 2006]. FS Date: 3/27/2013

LS- 7' x 14' concrete vault.
